# AlbCad Design

## Facade Inspection Report

This Site Inspection Report made today \_\_\_\_\_ by AlbCad Design, P.Eng. \_\_\_\_\_, for property (\_\_\_\_\_) actually owned by \_\_\_\_\_, commercial building attached both sides with one store building with (\_\_\_\_\_) on it's left side and (\_\_\_\_\_) on it's right side as it is shown in the site plan as for the picture below. The main façade of the building face the street Saint-Hubert.

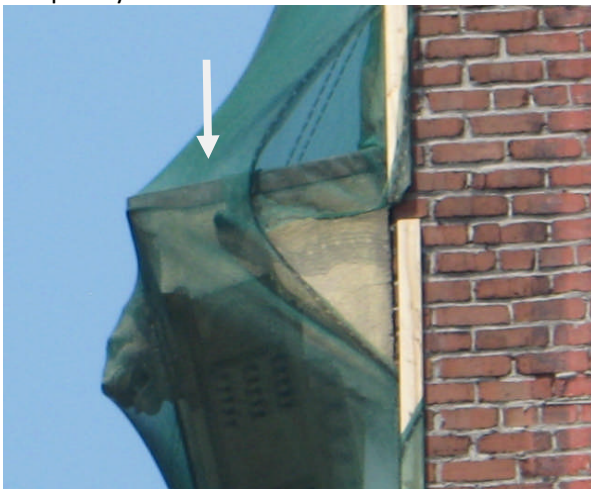
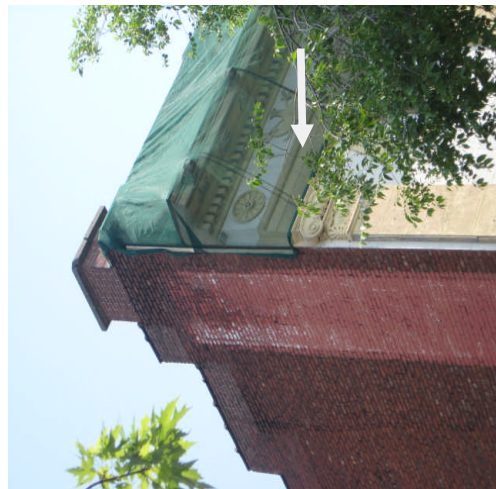
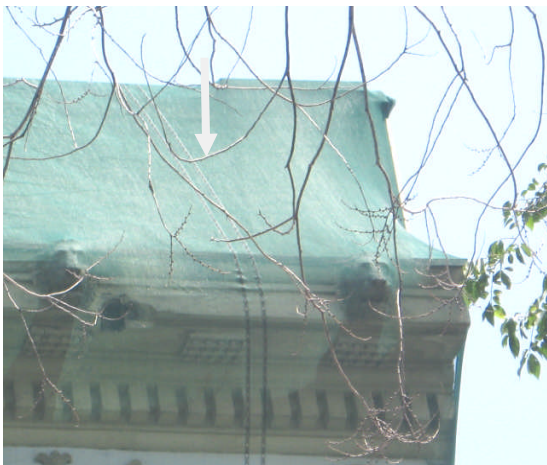
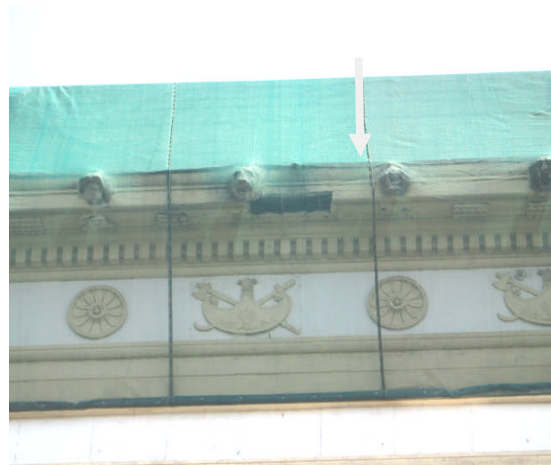
Site observation and carefully examinations of the main facade of the building makes it evident that the work done to cover the top part of the facade by means of the mesh, to stop the falling down any particular old small part from the top of the building, is properly done and fulfill the main purpose of being used. The mechanical properties of mash material selected and the way which installation was done makes it possibly to stop and save any small detached part from top of the facade decoration to falls down. This temporary measure, seems to perform good at the time of inspection, in terms of bracing the exterior part of the facade and public safety and in our opinion it can make it's function for at least for 60.( sixty) days start from the date of the inspection was done. After the expiration of this period of time another inspection and follows up has to be done to insure the performance of this temporary measure.

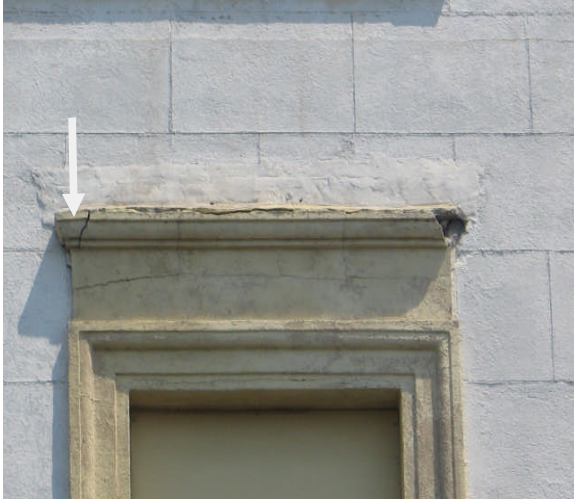
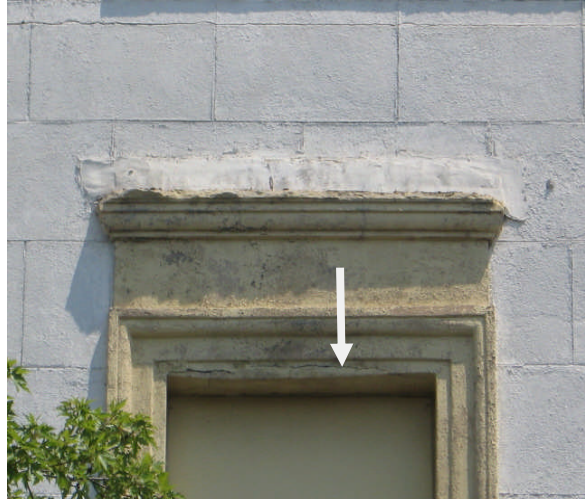
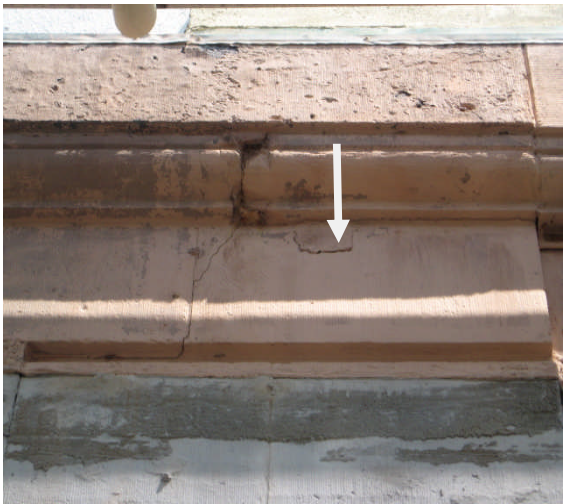
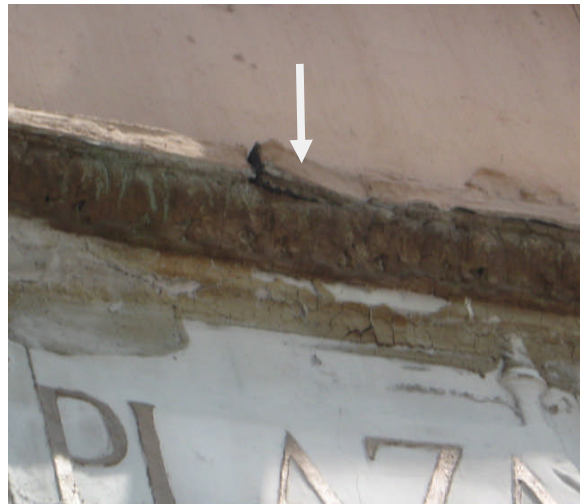
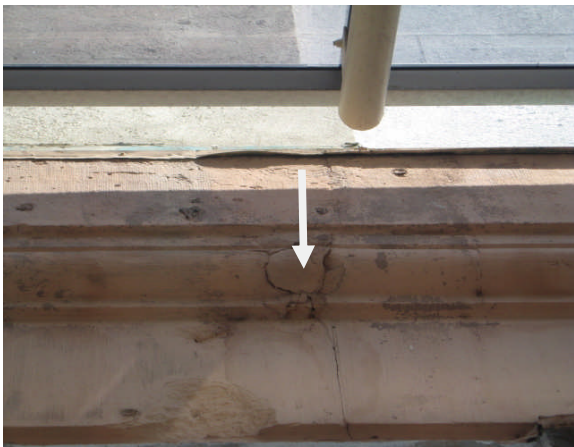
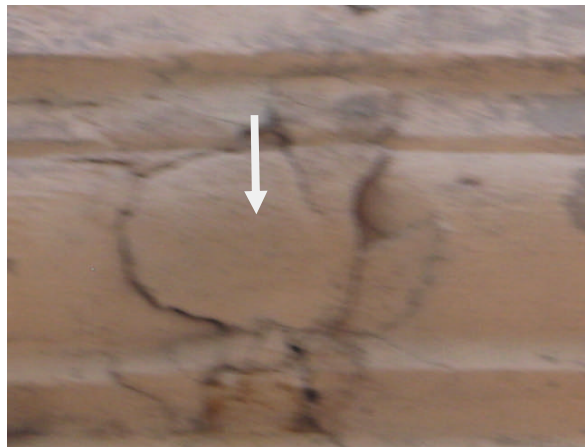
There some other little concerns to be expressed following and this related with some other small concrete or masonry particles in the main facade seems to be loose and may be cause for possible fallen in the near future. The mass and the weight of those loose small parts are not considered to be large enough to cause the serious damages or life threatens but still they may cause some troubles for public safety. **The positions of those particles are spotted in the pictures following, indicated by arrows, and it is strongly recommended those small concrete or masonry particles ( if it is not already tried to be removed for some of them) has to be removed by hammering them or cleaned by means of mechanical method to insure the stoppage of any one of those falling down.**
