AlbCad Design

Structural Inspection Report

Property description

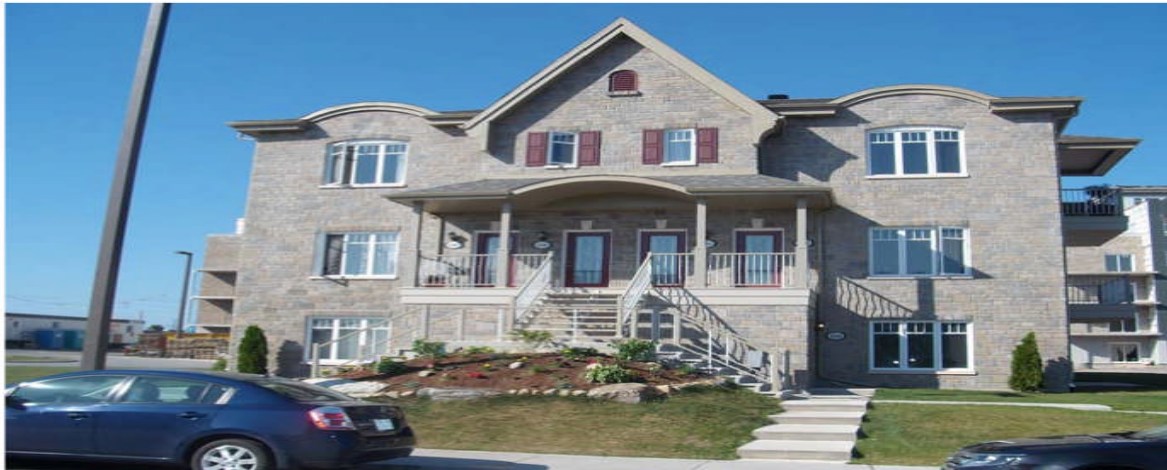
Photo 1

The property under study is a condominium, located at the first floor (see photo 2), on the right side of building stairs (see photo 1), divided in 6 condominium units; this building does not have a large basement, only a small section that is used as a storage room (see photo 3 and 4) for this unit; the other parts of the building are sitting on a concrete slab. The condo unit is divided in 6 rooms: a living-room, a dining-room, a kitchen, 3 bedrooms and a bathroom .At the basement, we noticed a small storage room (see photo 3). In the hall (see photo 5), modifications have been done to allow access to the basement: the wardrobe has been enlarged and the stair seems to have been moved and is not finished with any floor covering .

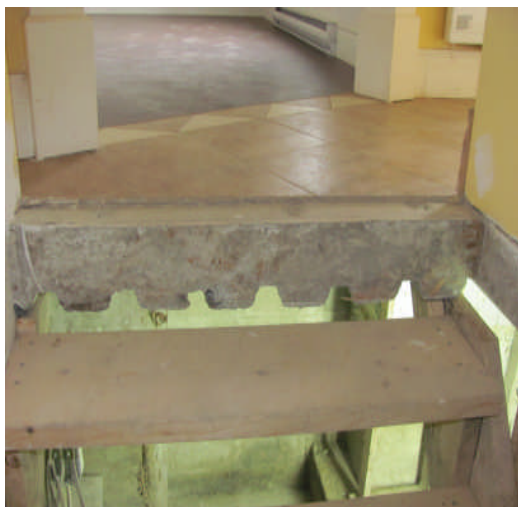
Photo 5

From visual inspection and carefully examinations by steel reinforcement detector of 5" thick suspended concrete slab structure which stands between the ground floor of the unit and the basement cavity , it is evident that the concrete itself doesn't contains (armature) rebar inside. (Photo 5 and 6)

The first concern of the structure in terms of the strength and poor structural performance is the missing reinforcement (armature) inside the suspended concrete slab. **It is strongly recommended this concrete slab to be subject of further bracing and the methods and the details of this reinforcement will be shown at the architectural and engineering plans which will follow this report.**

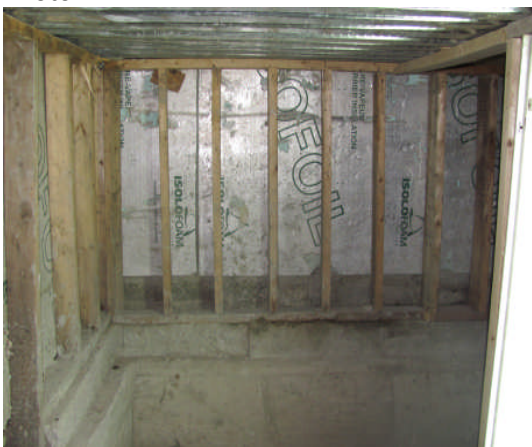
Photo 7

This concrete slab has been supported in three sides of the basement by means of 2 x 4 " wall made by wood studs and sitting on top of the foundation footings extended in depth. The structure of the supporting walls and bearing capacity seems not to be strong and safe enough to hold the suspended concrete slab sitting on top of it. The concrete slab seems not to have any side of it sitting or being connected with concrete foundation wall and in some places the wood wall structure holding the concrete slab doesn't sit well over the extended concrete foundation footings. Furthermore this concrete slab holding structure is totally unacceptable, it has to be noncombustible and the needs for further steps in terms of the structure safety is a must. (Photo 7,8 and 9)

It is strongly recommended this structure of supporting wall holding suspended concrete slab to be subject of further bracing and the methods and the details of this reinforcement will be shown at the

architectural and engineering plans which will follow this report.

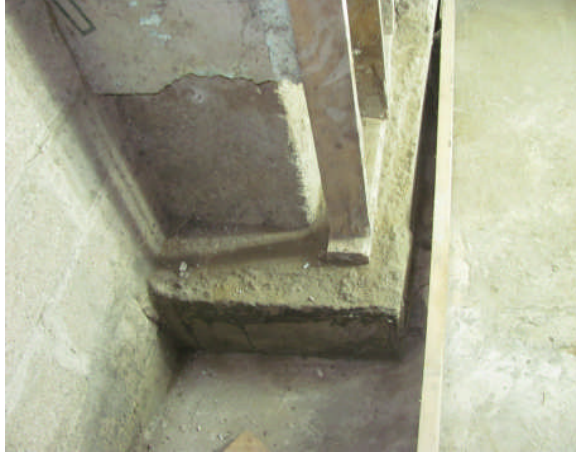
Photo 10

The existing foundation walls has been lowering by means of the concrete footing under benching and this foundation basement lowering seems to be done well and satisfies minimum necessary requirements for this kind of foundation modifications. (Photo 10 and 11).

Concrete bench under the existing foundations footing seems to perform well at the time of inspection was taking place. The two new block wall on interior part of the perimeter of the main foundation wall seems to perform well but some concerns still exist in terms of the wall humidity. There is a little spot at the lower part of the concrete block wall and seems that some humidity is evident there. Further actions has to be taken and some waterproof membrane has to be placed at least inside part of this wall. The concrete slab in the floor of the basement seems to be well done and performing well at the time of the inspection. We inspected the outside of the foundation: there is neither disorder sign, nor any abnormal crack on the
