# AlbCad Design

## Facade Inspection Report

This Site Inspection Report made today \_\_\_\_\_ by AlbCad Design, P.Eng. \_\_\_\_\_, for property (\_\_\_\_\_) actually owned by \_\_\_\_\_, commercial building attached both sides with one store building with (\_\_\_\_\_) on it's left side and (\_\_\_\_\_) on it's right side as it is shown in the site plan as for the picture below. The main façade of the building face the street Saint-Hubert.

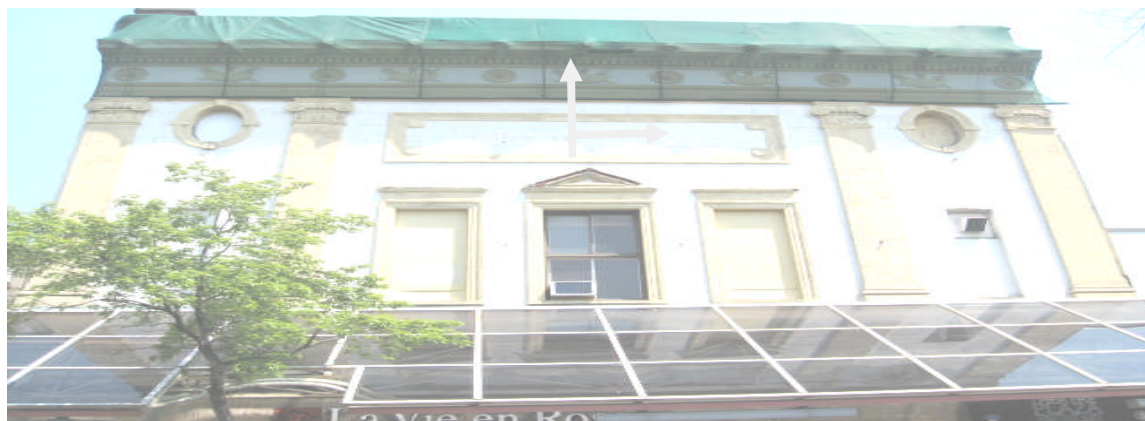
Site observation and carefully examinations of the main facade of the building makes it evident that the work done to cover the top part of the facade by means of the mesh, to stop the falling down any particular old small part from the top of the building, is properly done and fulfill the main purpose of being used. The mechanical properties of mash material selected and the way which installation was done makes it possibly to stop and save any small detached part from top of the facade decoration to falls down. This temporary measure, seems to perform good at the time of inspection, in terms of bracing the exterior part of the facade and public safety and in our opinion it can make it's function for at least for 60.( sixty) days start from the date of the inspection was done. After the expiration of this period of time another inspection and follows up has to be done to insure the performance of this temporary measure.
