AlbCad Design

Structural Inspection Report

Property description

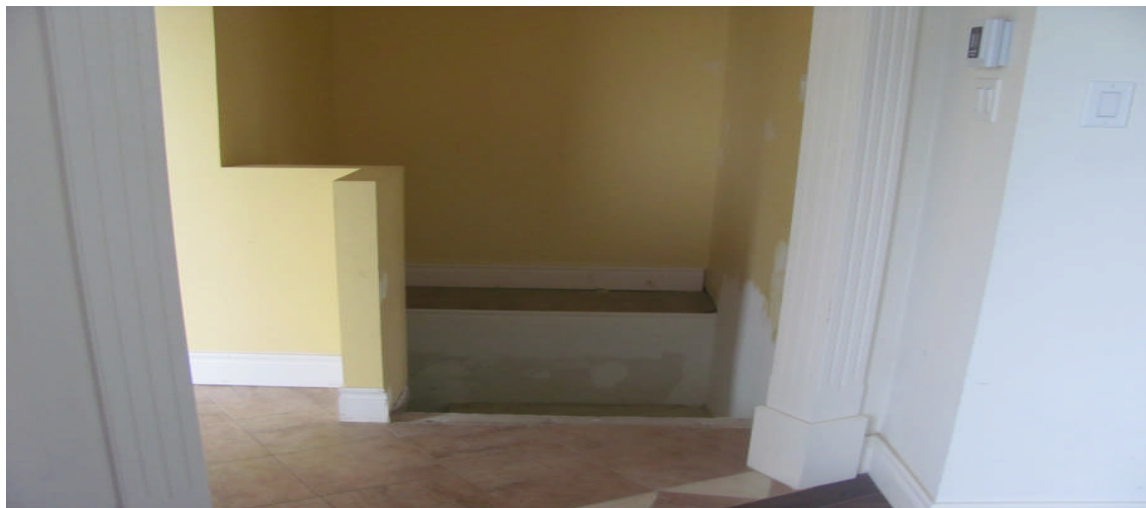
Photo 5

From visual inspection and carefully examinations by steel reinforcement detector of 5" thick suspended concrete slab structure which stands between the ground floor of the unit and the basement cavity , it is evident that the concrete itself doesn't contains (armature) rebar inside. (Photo 5 and 6)

The first concern of the structure in terms of the strength and poor structural performance is the missing reinforcement (armature) inside the suspended concrete slab. **It is strongly recommended this concrete slab to be subject of further bracing and the methods and the details of this reinforcement will be shown at the architectural and engineering plans which will follow this report.**
